FLIGHT MEASUREMENTS OF LATERAL AND DIRECTIONAL  
STABILITY AND CONTROL CHARACTERISTICS  
OF THE GRUMMAN F8F-1 AIRPLANE

TED NO. NACA 2379

H. L. Crane and J. P. Reeder

Langley Memorial Aeronautical Laboratory  
Langley Field, Va.

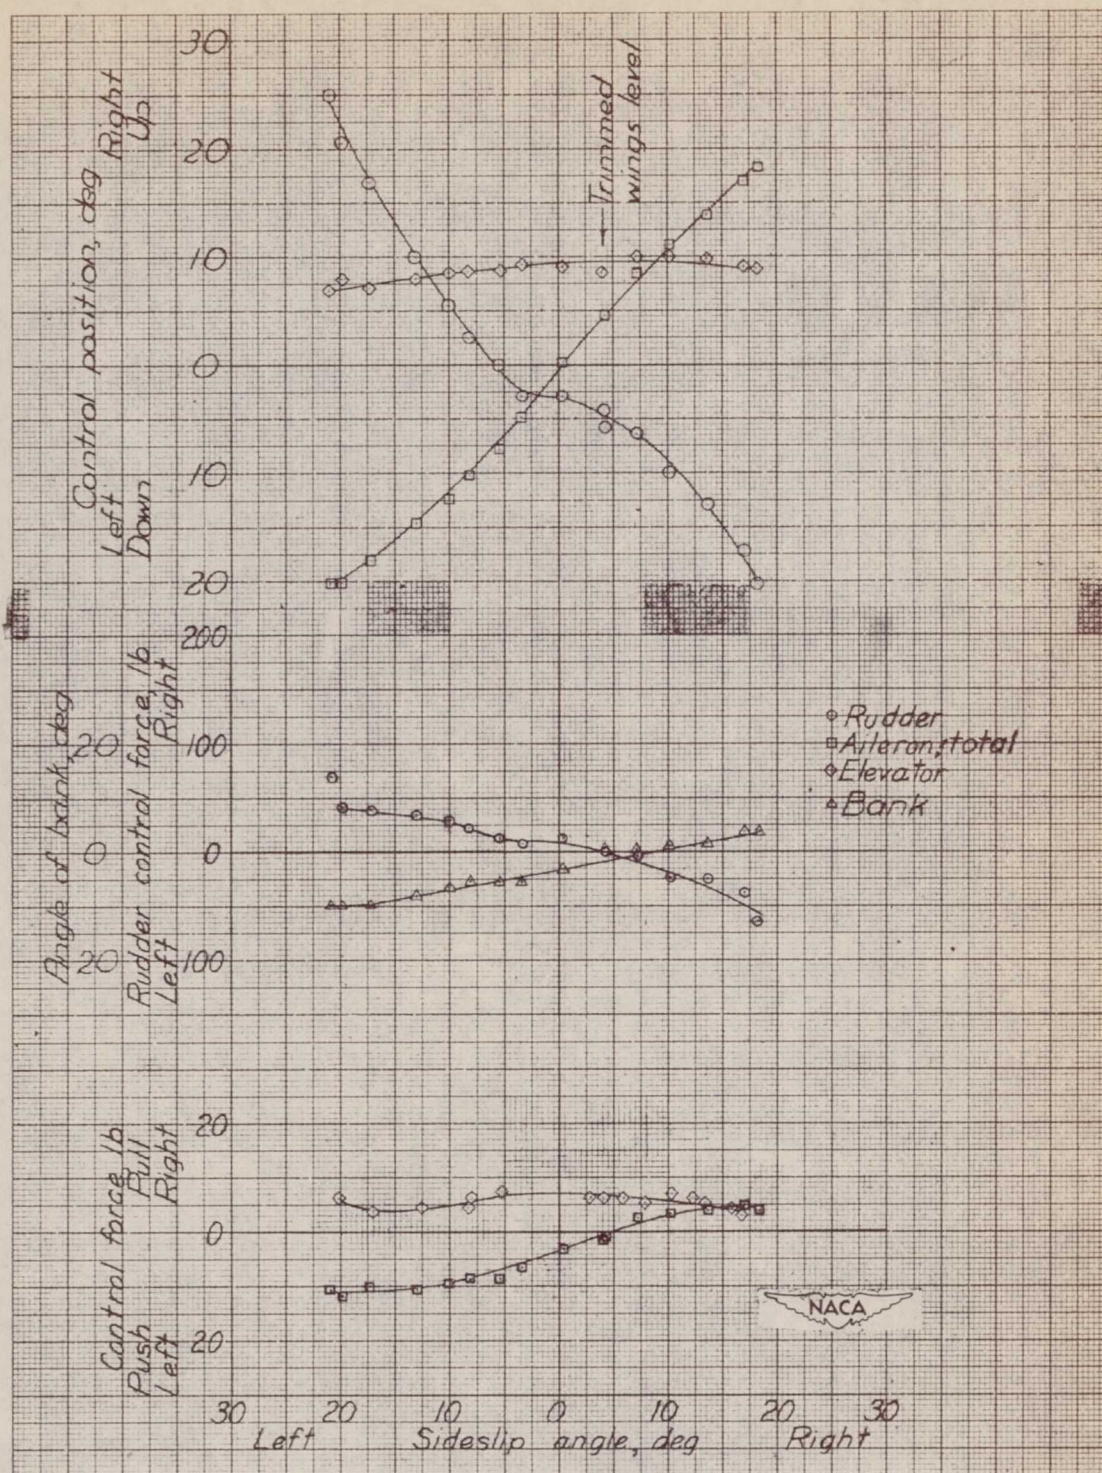
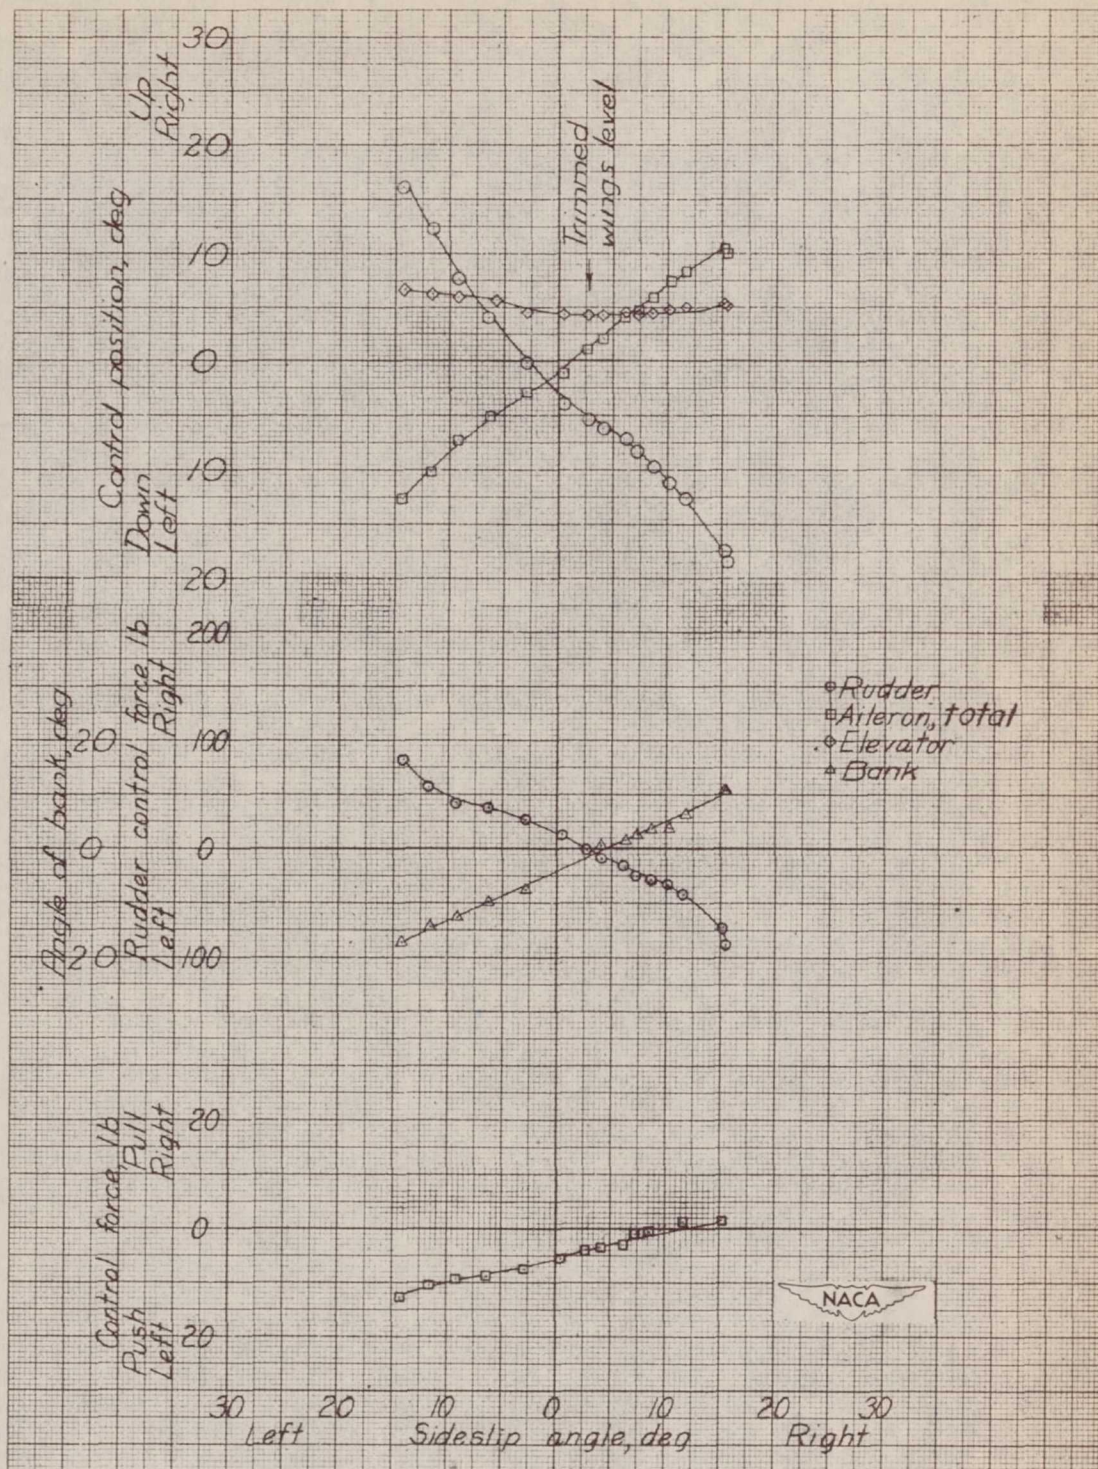
(a) 105 miles per hour, rudder tab  $14.7^\circ$  right.

Figure 21.- Sideslips in the landing condition with engine idling and flaps and landing gear down at 5000 feet, with belly tank on, cowl closed, oil cooler closed, canopy open, F8F-1 airplane with tail configuration 1.

(b) 150 miles per hour, rudder tab  $12.8^\circ$  right.

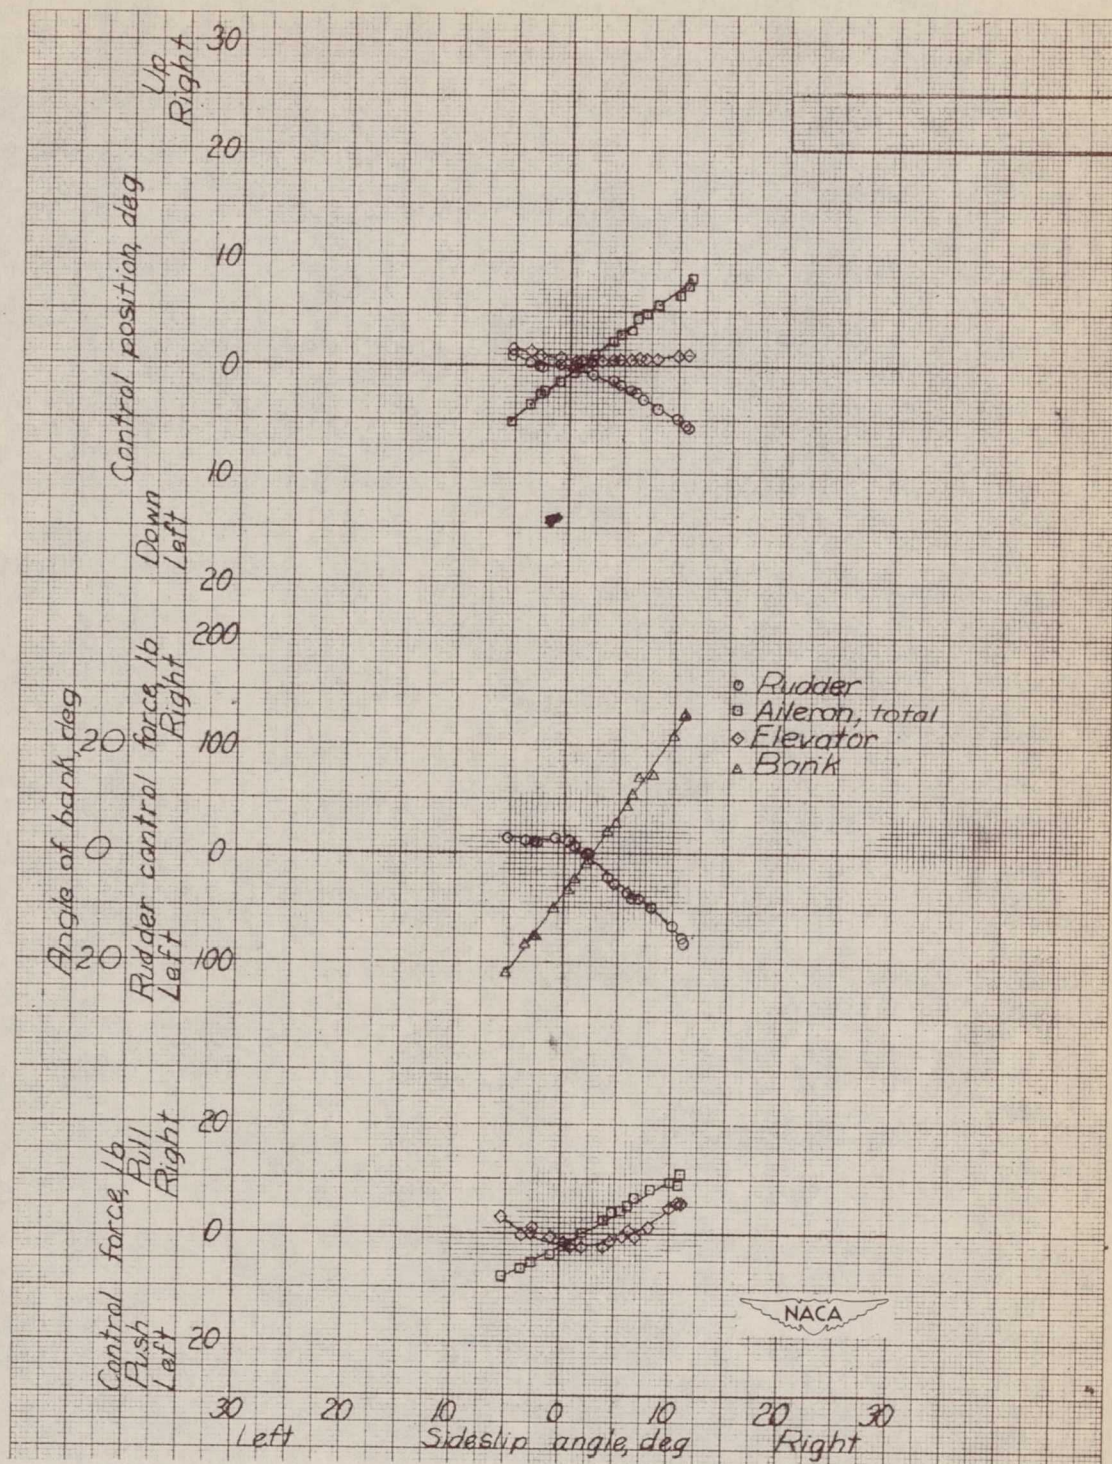
Figure 22.- Steady sideslips at 20,000 feet in the rated-power, clean condition (41 in. Hg at 2600 rpm) at 300 miles per hour with belly tank on. F8F-1 airplane with tail configuration 1.

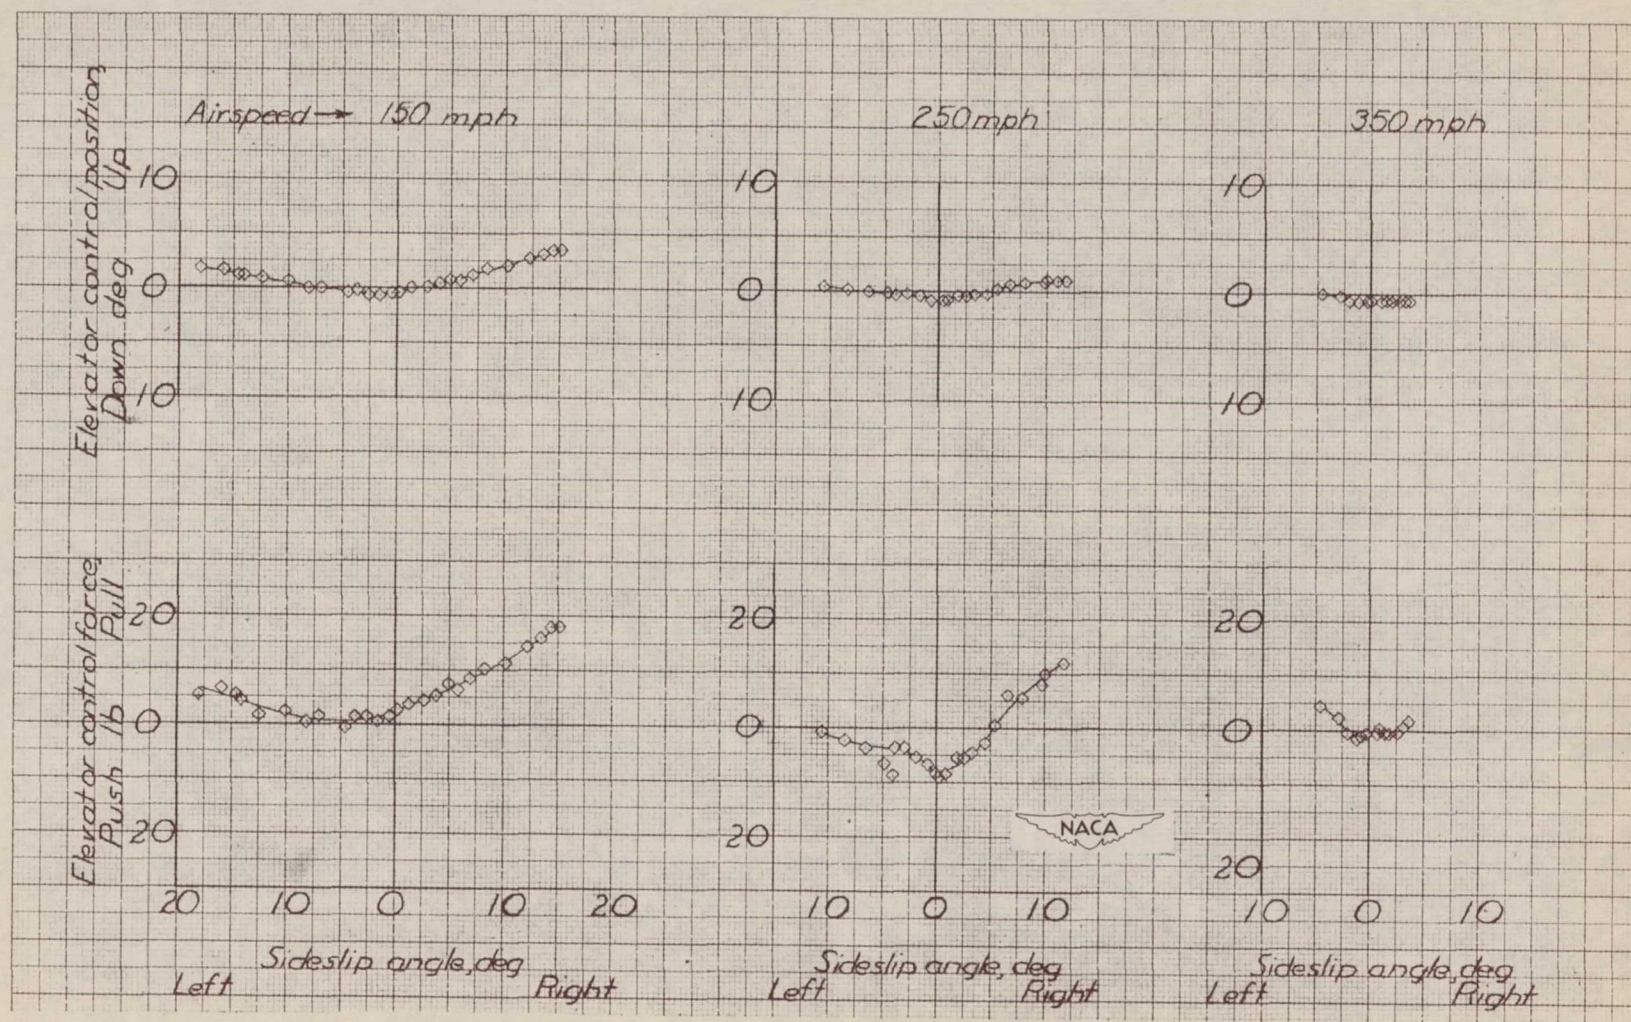
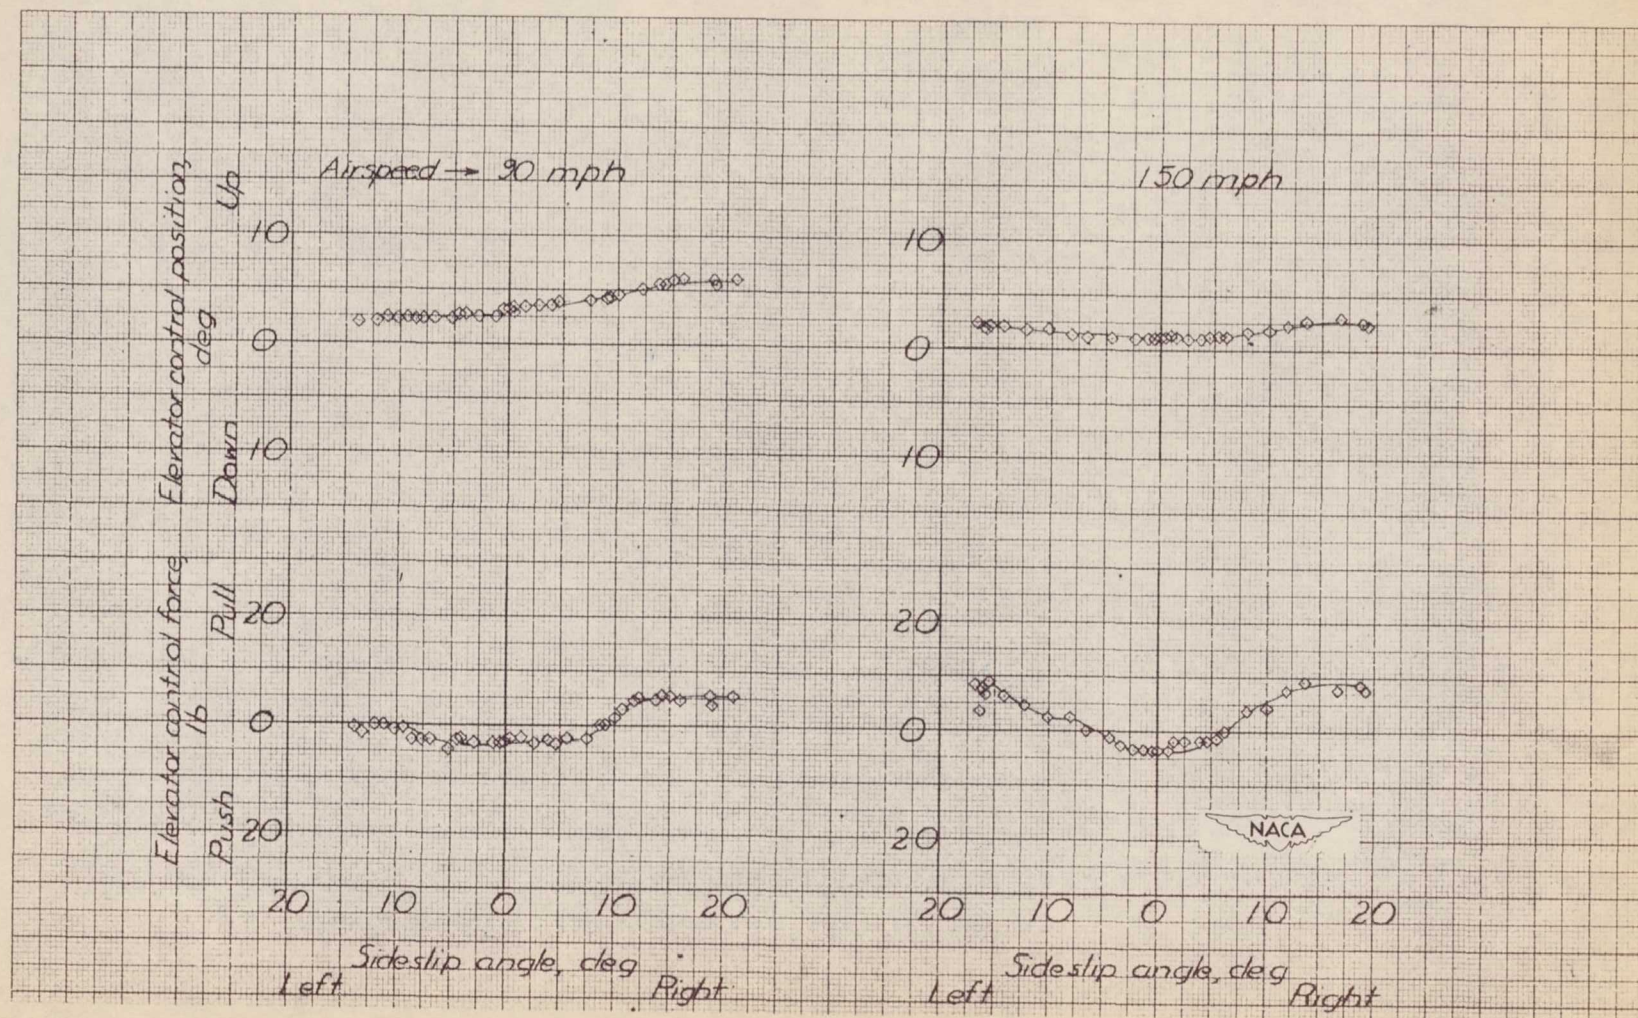
(a) Rated-power, clean condition.

Figure 23.- Variation of elevator position and control force with angle of sideslip. F8F airplane with tail configuration 2.

(b) Power-approach condition.

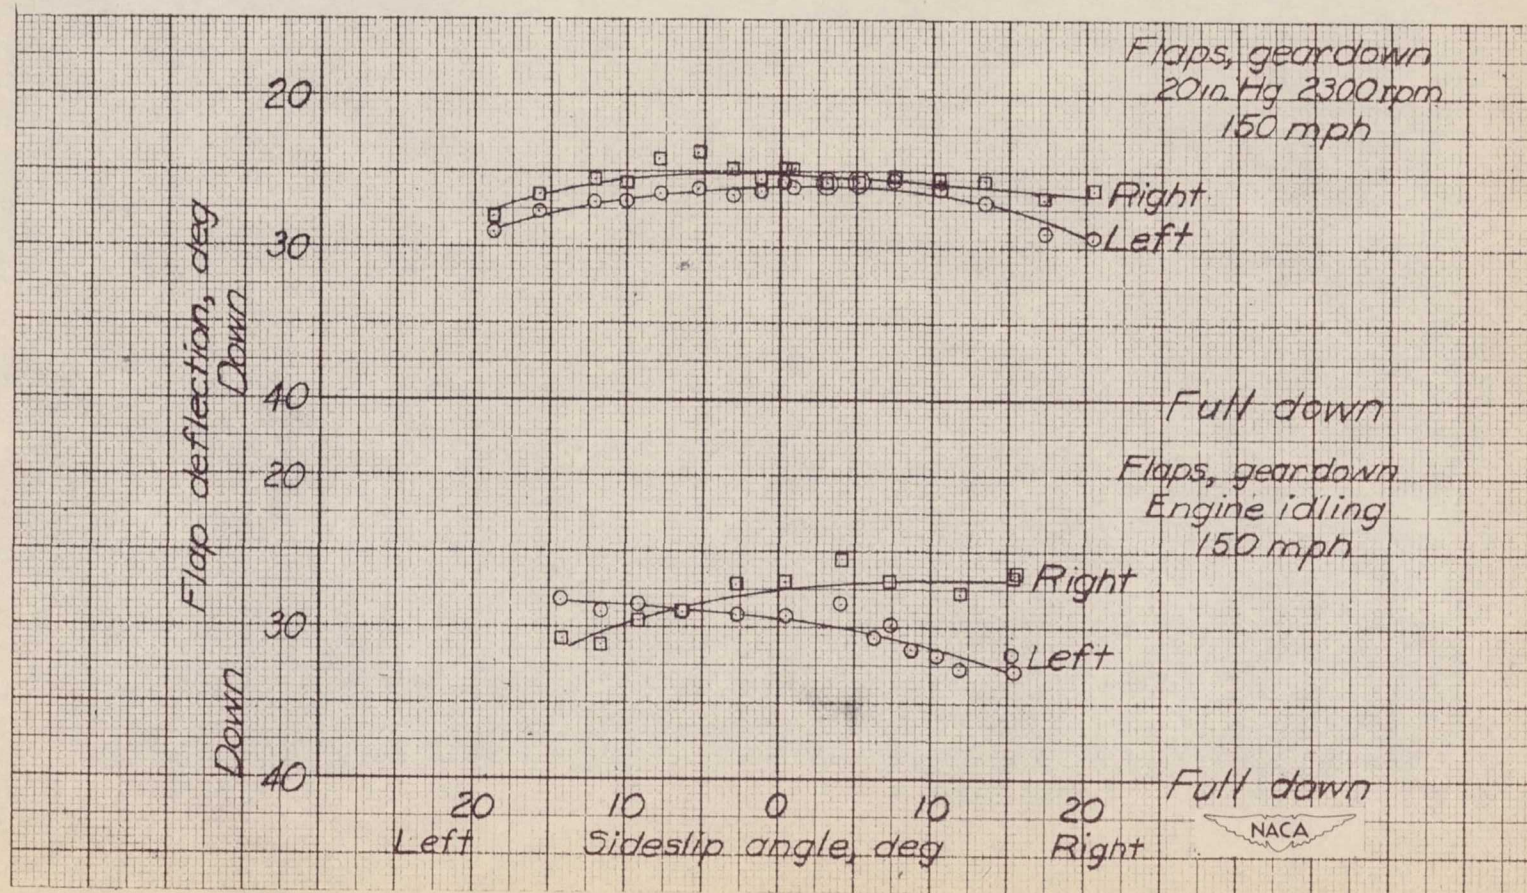
Figure 24.- Flap blow-up in sideslips at 150 miles per hour, belly tank on, F8F-1 airplane.

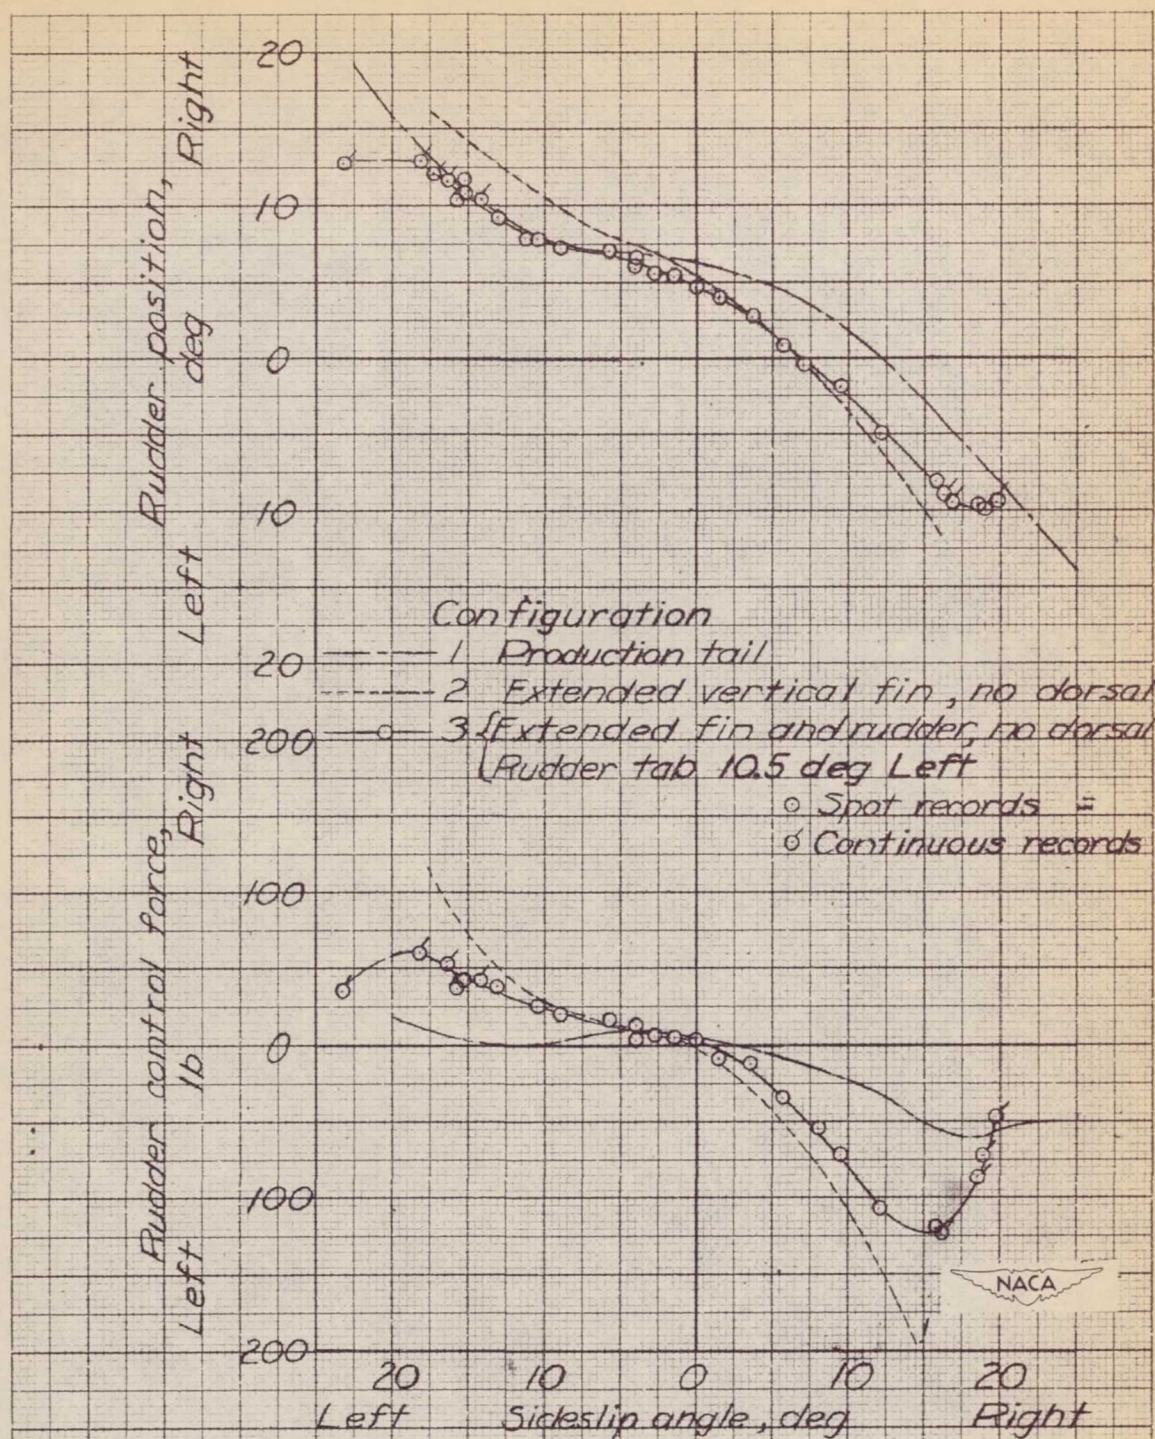
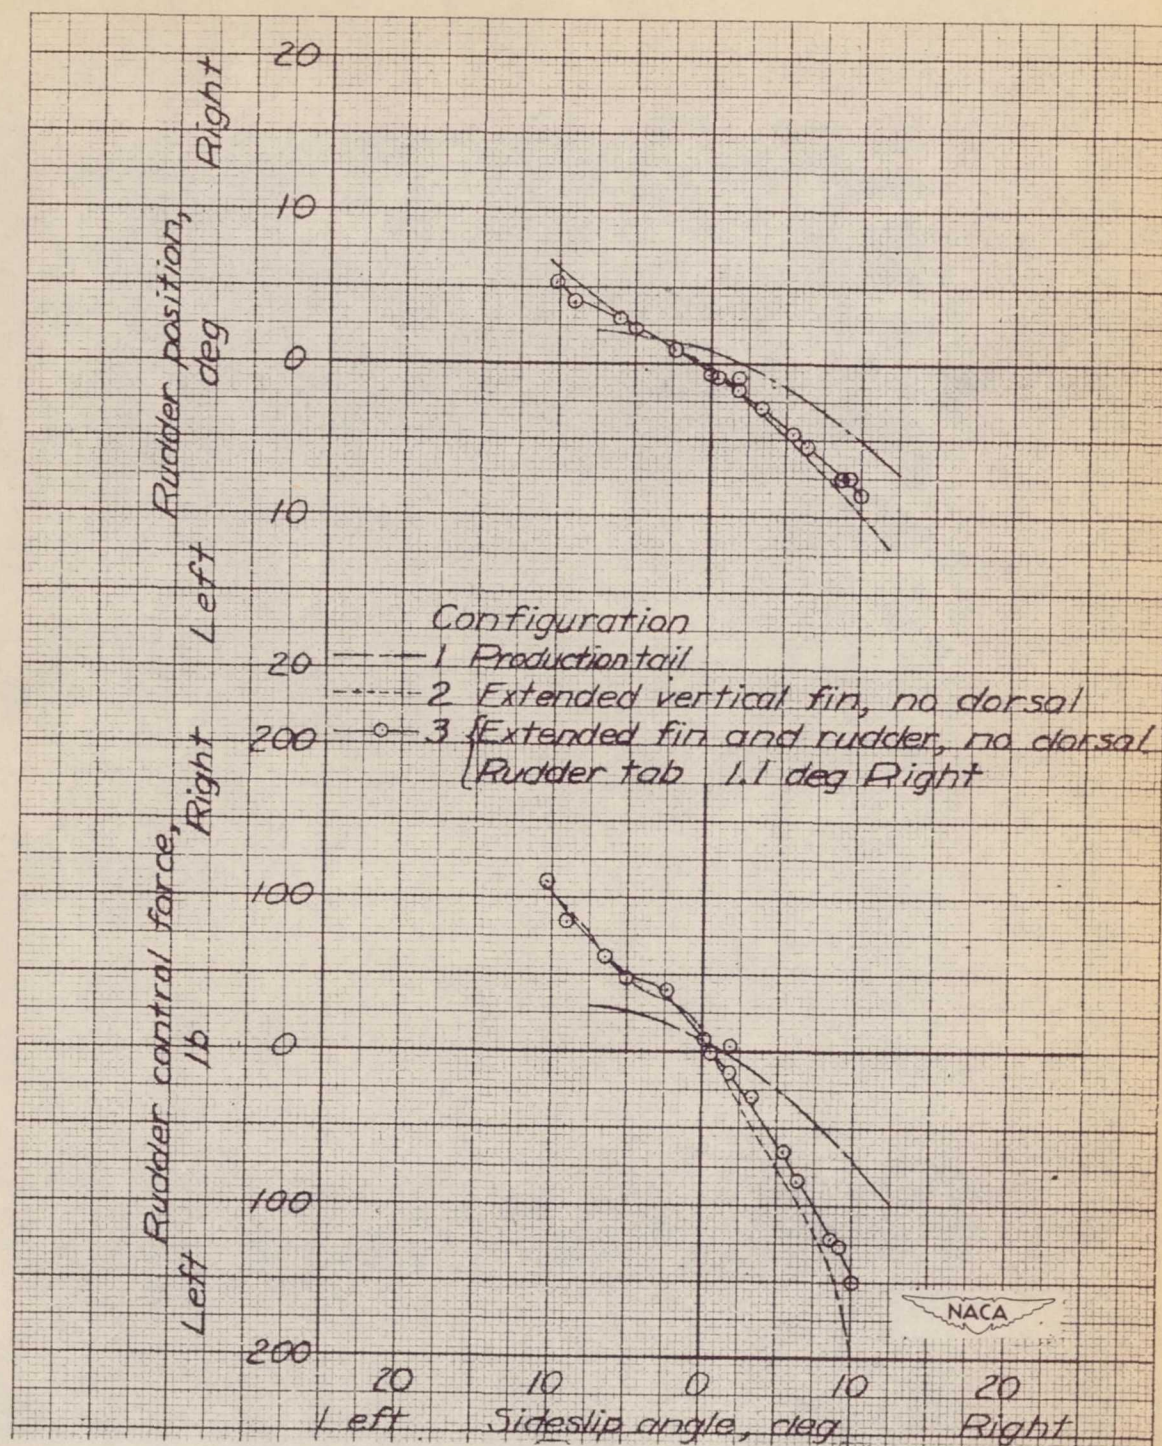
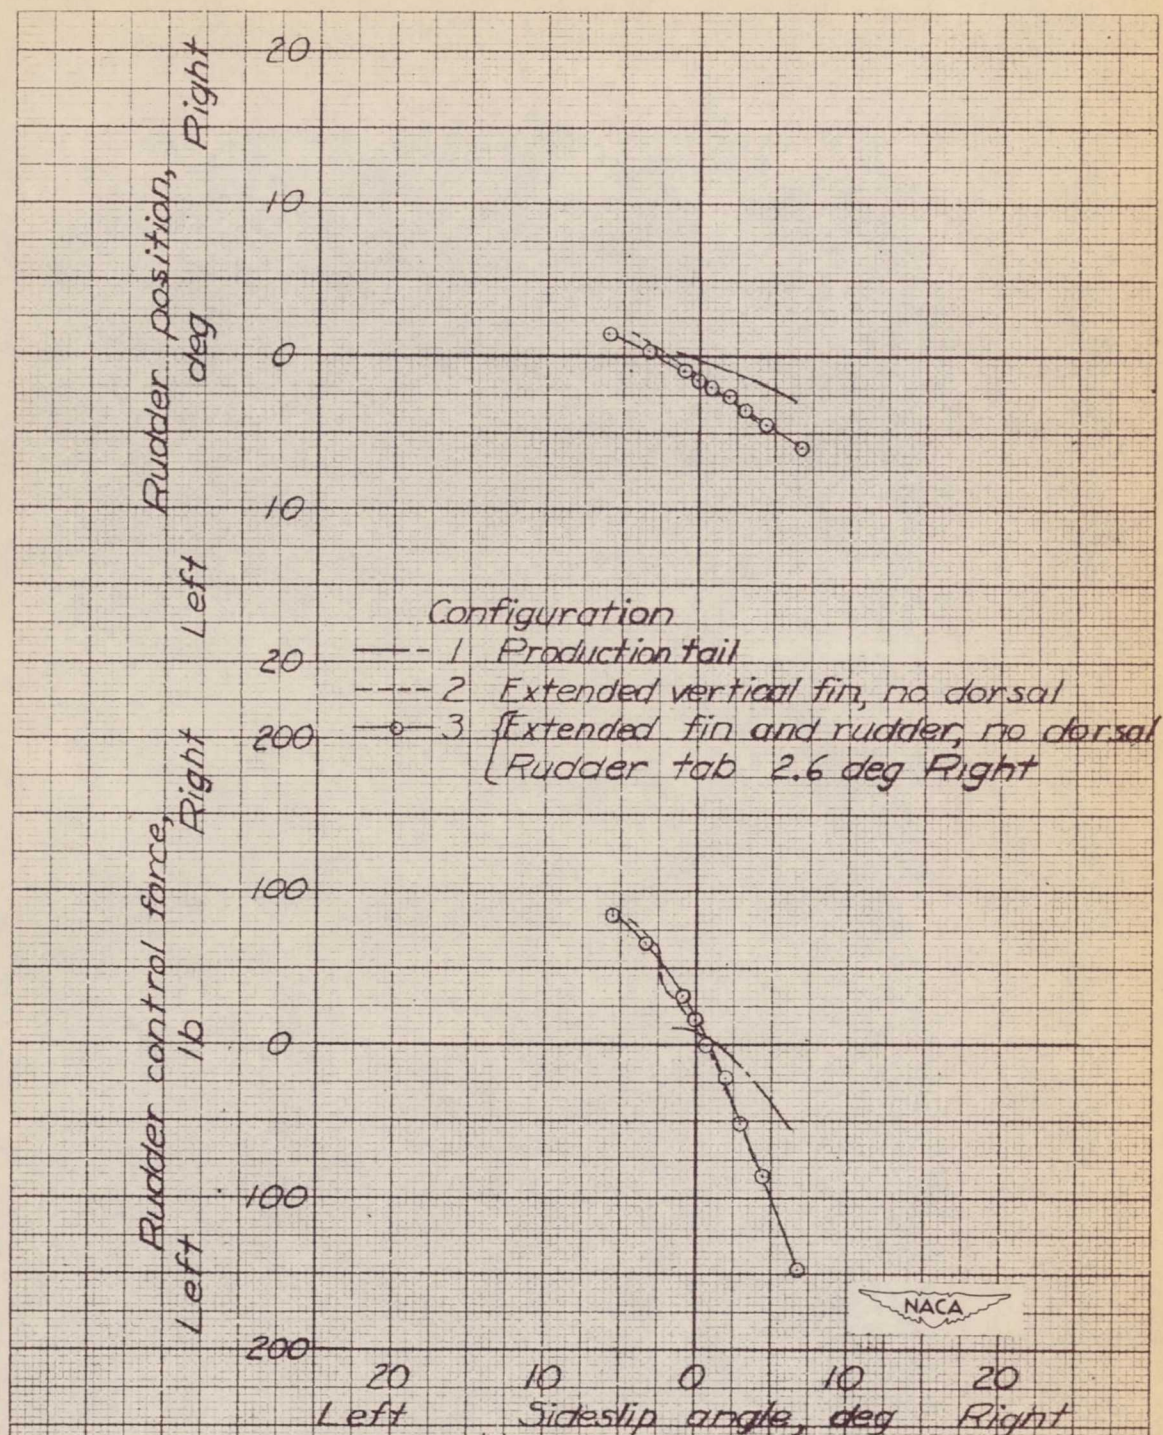
(a) 150 miles per hour.

Figure 25.- Steady sideslip characteristics in the rated-power, clean condition (41 in. Hg at 2600 rpm) with three vertical tail configurations. F8F-1 airplane.

(b) 250 miles per hour.

(c) 350 miles per hour.

Figures 25 and 26 present a comparison of the directional stability characteristics with the three vertical-tail configurations with the belly tank installed. The data of figures 25 and 26 indicate that either vertical-tail configuration 2 or configuration 3 improved the directional stability at small sideslip angles where there had been a deficiency with tail configuration 1. In the rated-power, clean condition at 150 miles per hour (fig. 25(a)) where the control-free directional stability in left sideslips had been zero with tail configuration 1, there was definite positive control-free stability with either tail configuration 2 or 3.

Comparison of the curves of rudder force and position against angle of sideslip in figures 25 and 26 shows that tail configurations 2 and 3 produced increases in directional stability. The following table presents the values of the directional-stability parameters,  $d\delta_r/d\beta$ , the rate of change of rudder position with angle of sideslip, and  $dF_r/d\beta$ , the rate of change of rudder control force with angle of sideslip, measured between  $0^\circ$  and  $5^\circ$  with the three vertical tails in two flight conditions with belly tank installed at several speeds. The minimum slopes usually occurred between  $0^\circ$  and  $5^\circ$  left sideslip.

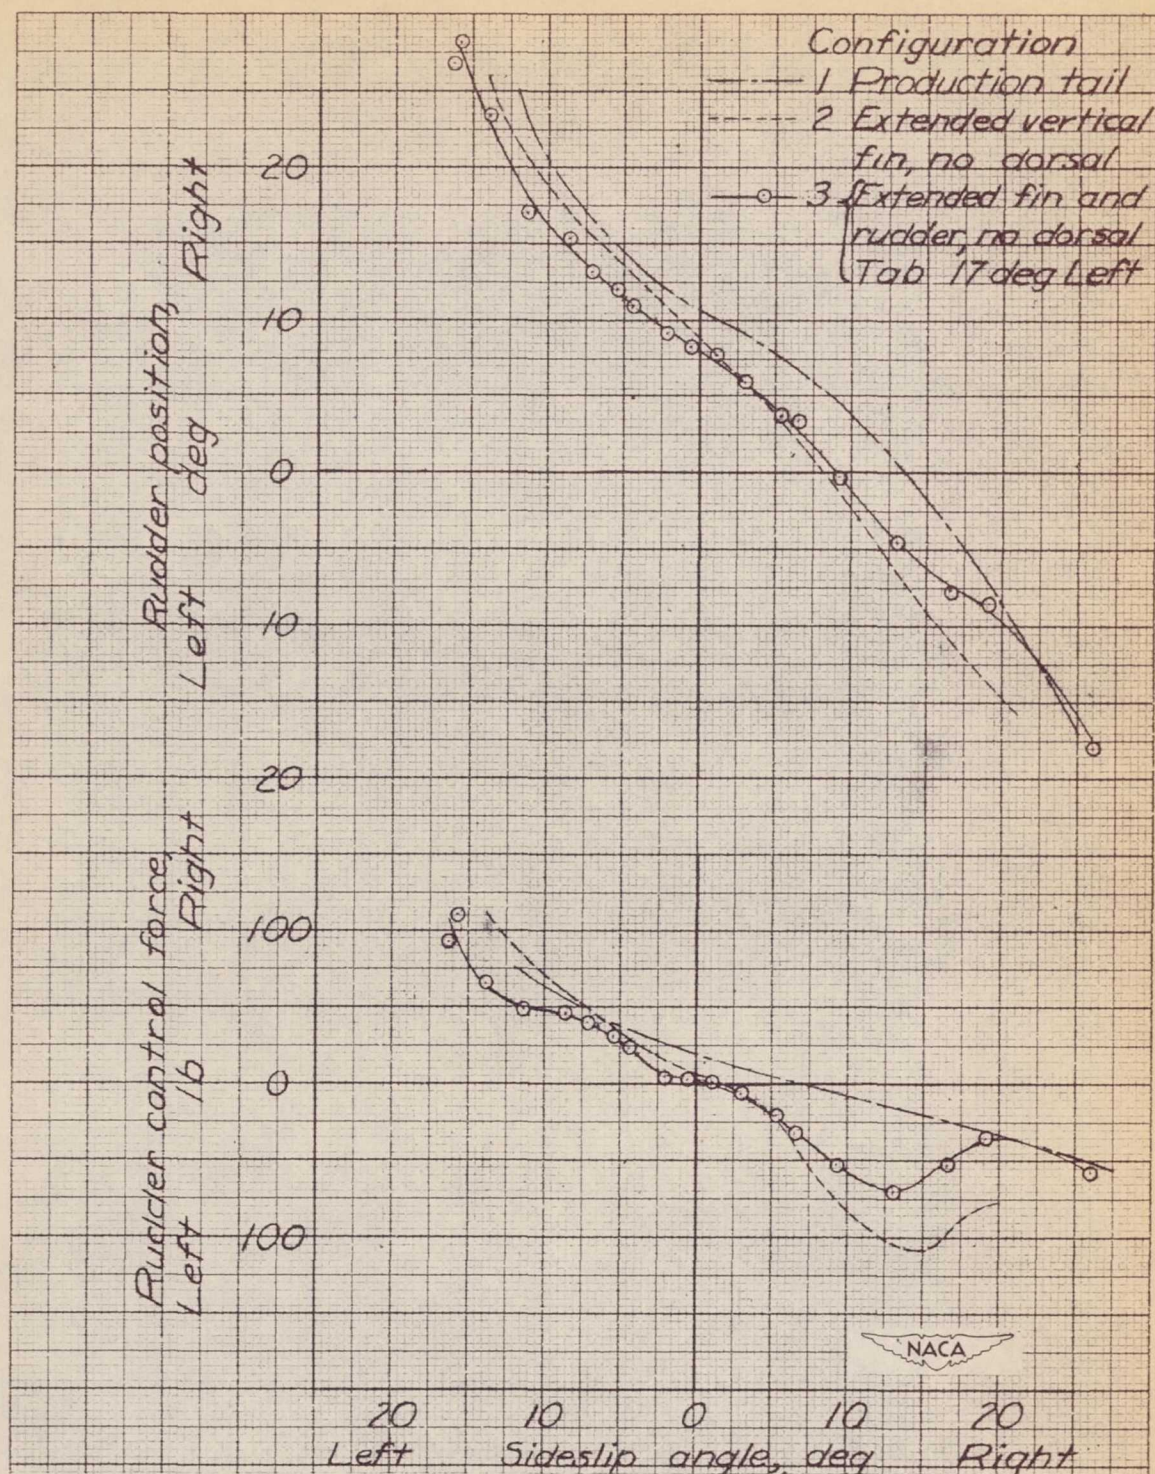
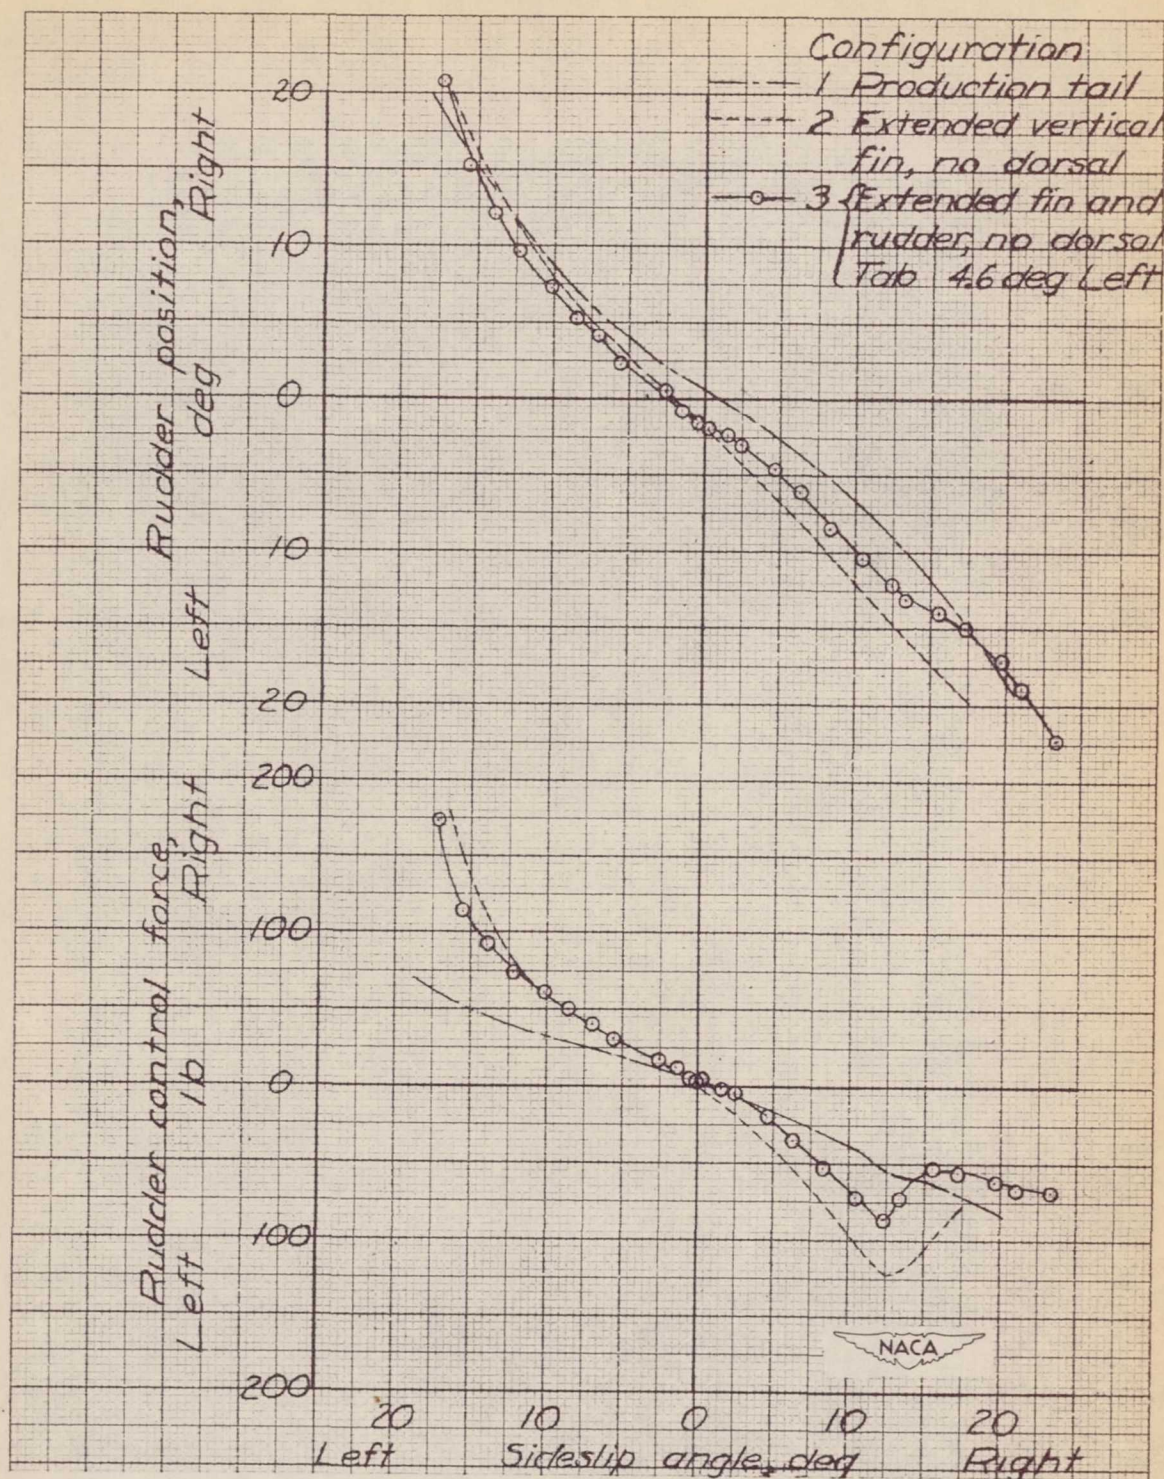
(a) 90 miles per hour.

Figure 26.- Steady sideslip characteristics in the power-approach condition (18-20 in. Hg at 2300 rpm), flaps and landing gear down with three vertical tail configurations F8F-1 airplane.

(b) 150 miles per hour.

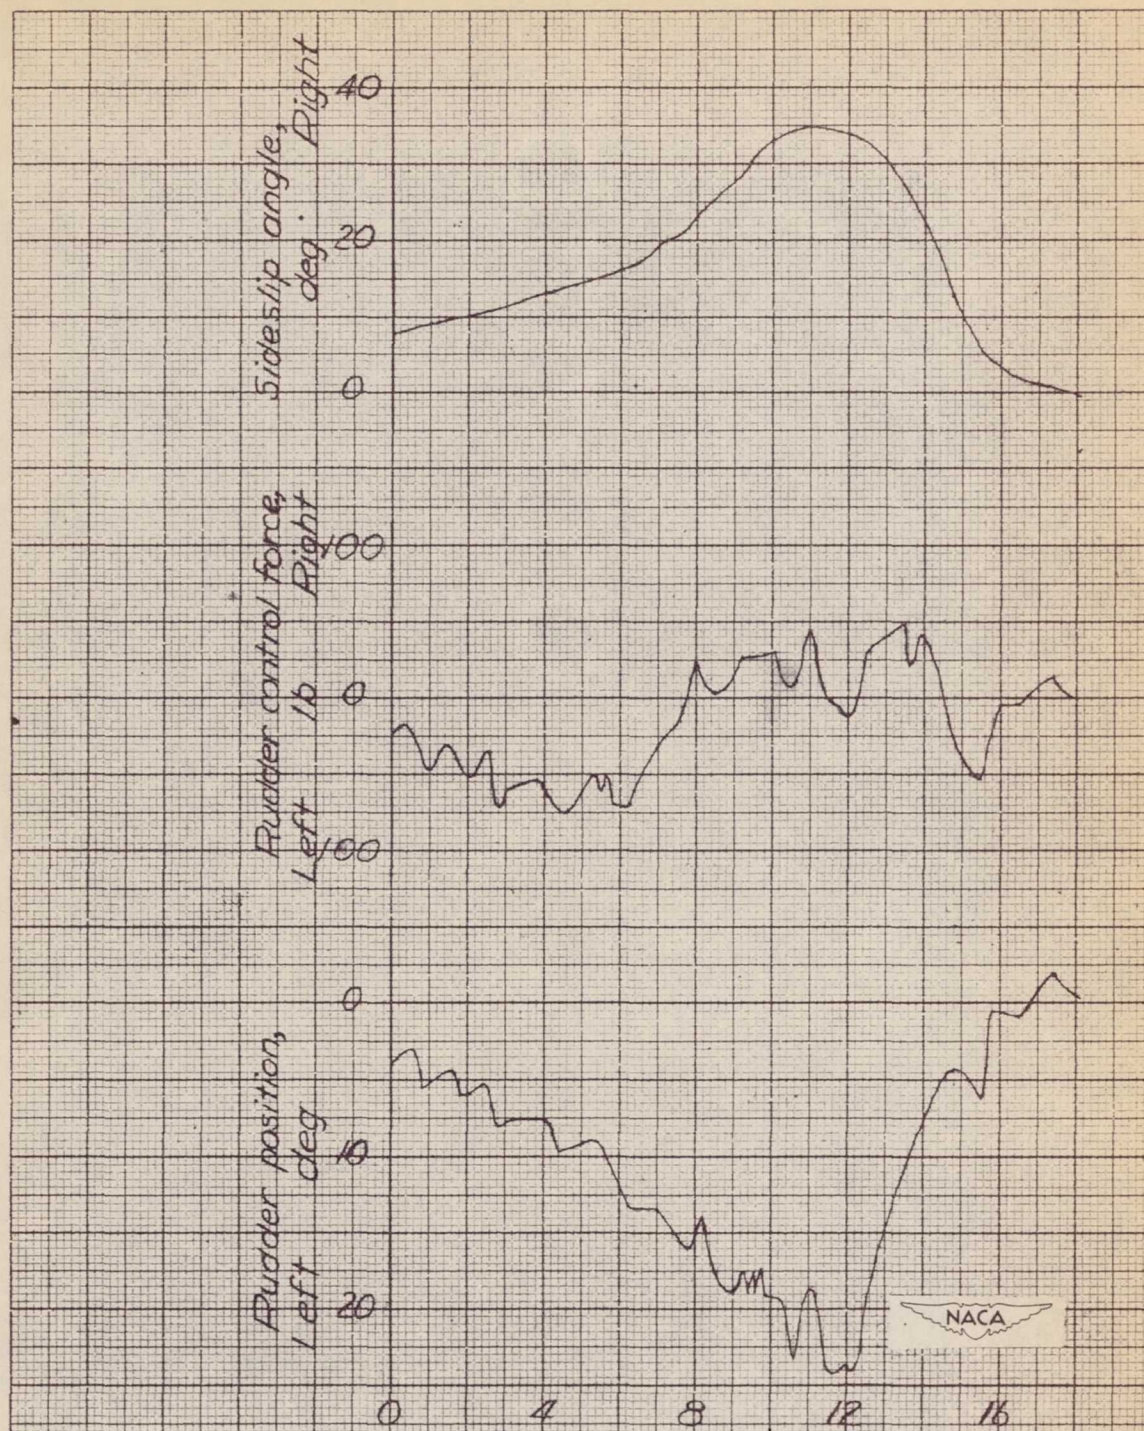
Figure 27.- Time history of right sideslip at approximately 120 miles per hour in the power-approach condition (30 in. Hg, 2200 rpm, flaps and landing gear down) during which rudder overbalance occurred, F8F-1 airplane with tail configuration three, belly tank on.

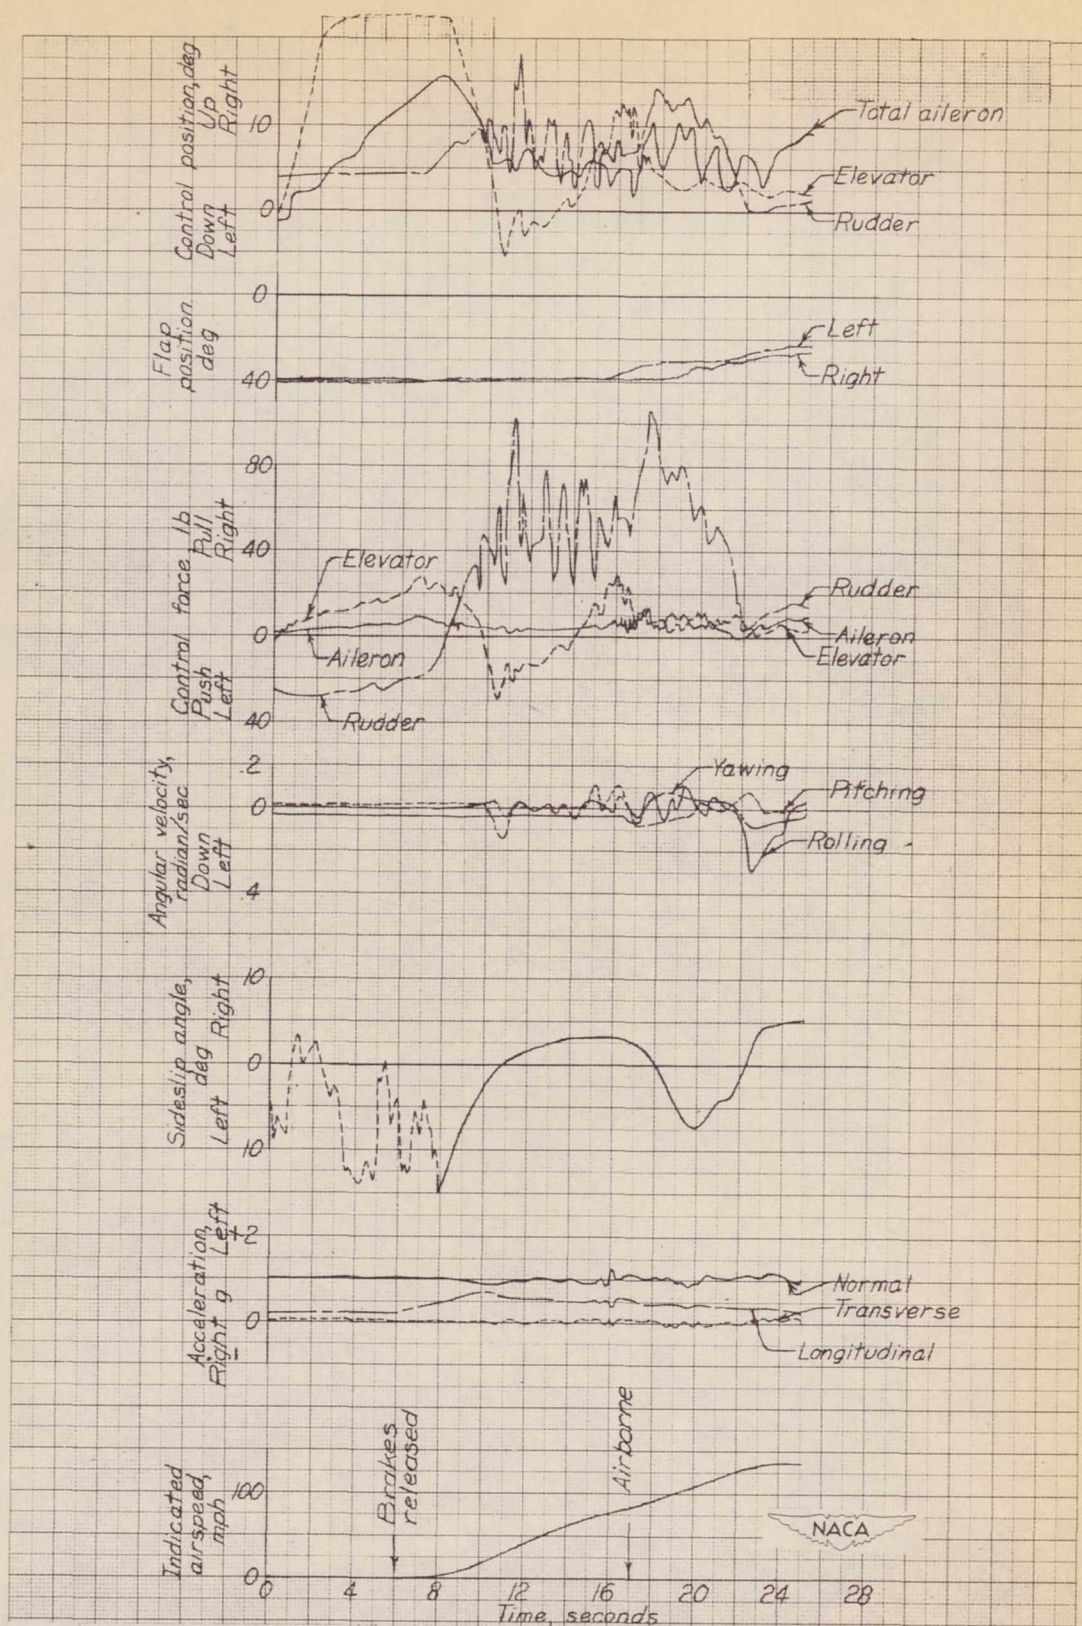
Figure 28.- Time history of simulated carrier take-off (54 in. Hg, 2800 rpm), by a service pilot. F8F-1 airplane with tail configuration 1.
